Architectural Restoration of the Tegalsari Grand Mosque, Jetis, Ponorogo, East Java (1994–1997 CE)

Stages of the Architectural Restoration of the Tegalsari Grand Mosque (1994–1997 CE)

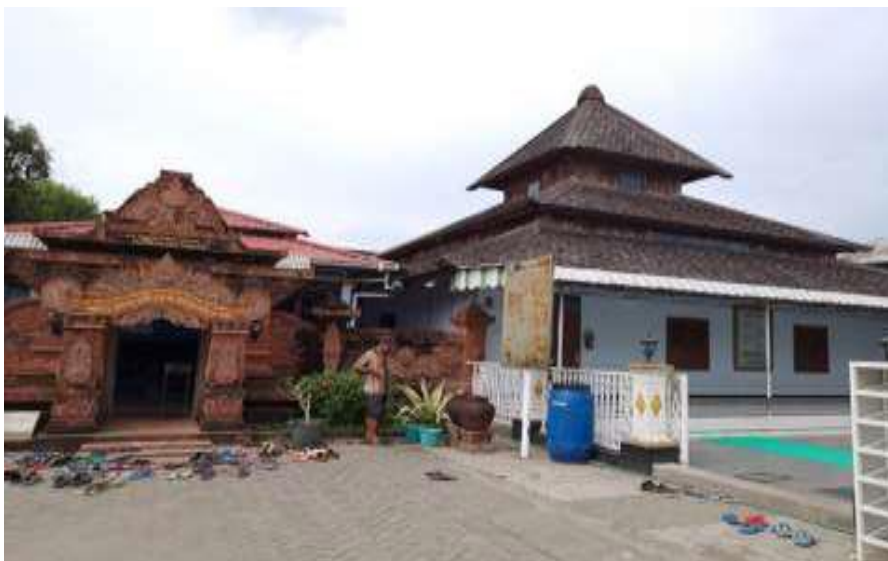
Figure 2. Photograph of the Three-Tiered Roof of the Mosque
Source: author's documentation

The mosque's three-tiered (*atap tumpang*) roof carries complex symbolic meanings, functioning both as a representation of *shari'a*, *ma'rifa*, and *haqiqa*, and as a symbol of *Iman*, *Islam*, and *Ihsan*. At its apex stands a *kemuncak* in the form of an inverted earthen jar, which serves as an ornamental feature as well as a talismanic element intended to ward off misfortune, in accordance with local traditional beliefs. The mosque's fence, designed with curved forms projecting outward, is interpreted as a symbol of Allah's protection over the Muslim community from satanic disturbances and external threats. The presence of the tomb of Kiai Ageng Muhammad Besari within the mosque complex further reinforces the symbolic relationship between life and death, in which the mosque is understood as a space of piety and the tomb as a place of repose on the journey toward the hereafter (Salsabila, [2024](#)). Accordingly, all architectural elements of the Tegalsari Grand Mosque integrally reflect the synthesis of Islamic teachings, local traditions, and the spiritual values of Javanese society (Multazam, [2021](#)).

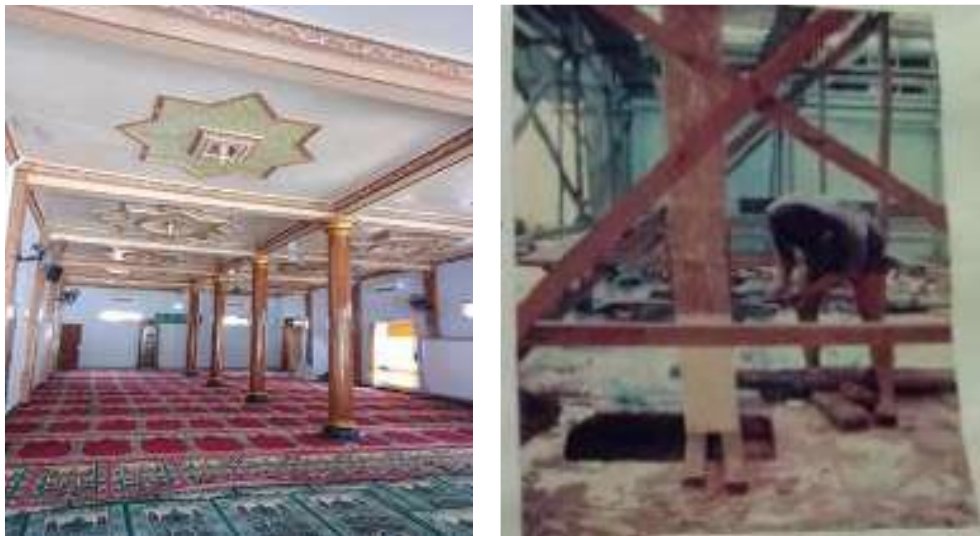
Figure 3. The Pawestren Space and the Process of Cutting the Serambi Columns

In the *serambi* area, dismantling was carried out comprehensively on the roof covering, structural frame, and columns, which were remnants of previous renovations. Non-original materials were separated for replacement, while original elements such as *usuk*, *blandar*, *jurai*, and truss columns were marked and registered so that they could be reinstalled in their original positions. The *serambi* floor was then dismantled to trace the presence of original *umpak* foundations concealed beneath layers of soil. Excavation revealed twelve andesite stone *umpak* with trapezoidal forms, which constituted an important component of the ancient mosque's structure. These *umpak* were conserved through thorough cleaning and the application of waterproof coatings to ensure the stability of the structural elements above them (Setyawan et al., [2017](#)).

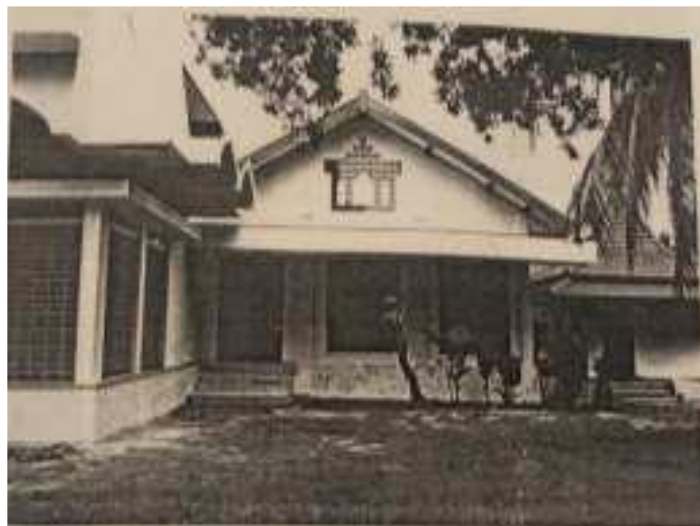
Figure 4. Photograph of the Restored Pawestren Viewed from the Front
Source: Cultural Heritage Preservation Agency (BPCB) East Java
