Architectural Restoration of the Tegalsari Grand Mosque, Jetis, Ponorogo, East Java (1994–1997 CE)

Adhelia Shelyn Lesvinanda*, Universitas Islam Negeri Sunan Kalijaga, Indonesia
Himayatul Itthadiyah, Universitas Islam Negeri Sunan Kalijaga, Indonesia

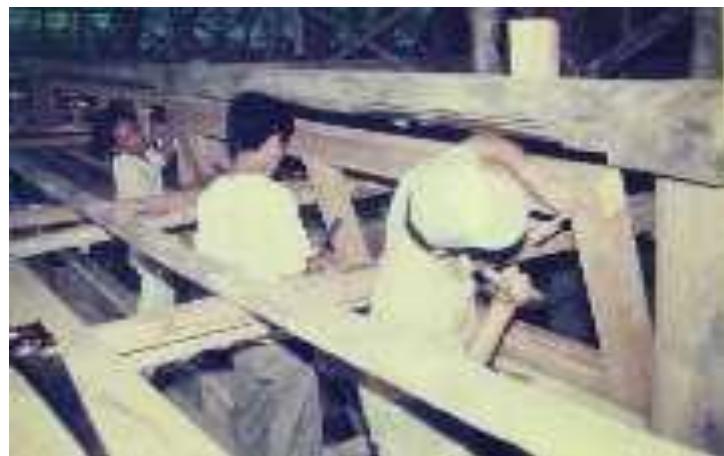
Figure 1. Photograph of the Installation of Wooden Wall Beams and Ventilation
Source: Cultural Heritage Preservation Agency (BPCB) East Java

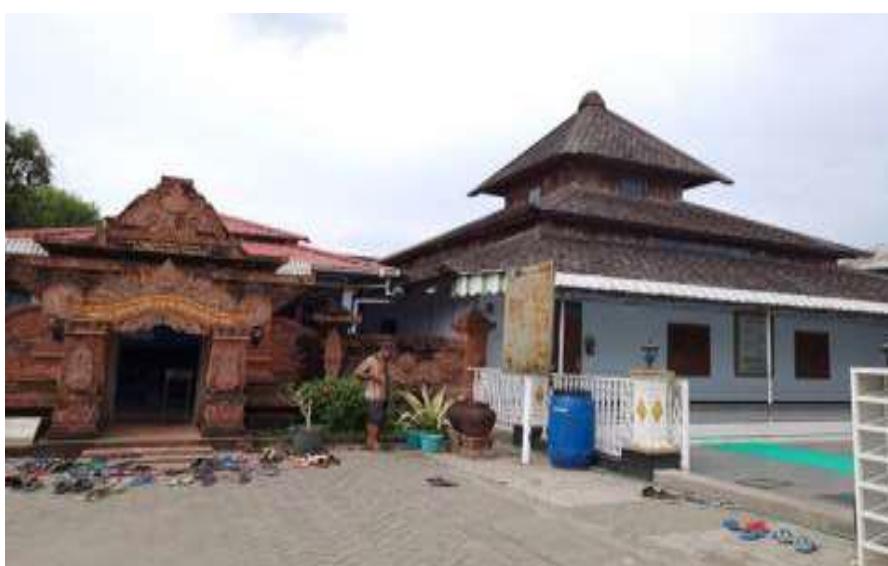
Figure 2. Photograph of the Three-Tiered Roof of the Mosque
Source: author's documentation

The mosque's three-tiered (*atap tumpang*) roof carries complex symbolic meanings, functioning both as a representation of *shari'a*, *ma'rifa*, and *haqiqa*, and as a symbol of *Iman*, *Islam*, and *Ihsan*. At its apex stands a *kemuncak* in the form of an inverted earthen jar, which serves as an ornamental feature as well as a talismanic element intended to ward off misfortune, in accordance with local traditional beliefs. The mosque's fence, designed with curved forms projecting outward, is interpreted as a symbol of Allah's protection over the Muslim community from satanic disturbances and external threats. The presence of the tomb of Kiai Ageng Muhammad Besari within the mosque complex further reinforces the symbolic relationship between life and death, in which the mosque is understood as a space of piety and the tomb as a place of repose on the journey toward the hereafter (Salsabila, [2024](#)). Accordingly, all architectural elements of the Tegalsari Grand Mosque integrally reflect the synthesis of Islamic teachings, local traditions, and the spiritual values of Javanese society (Multazam, [2021](#)).

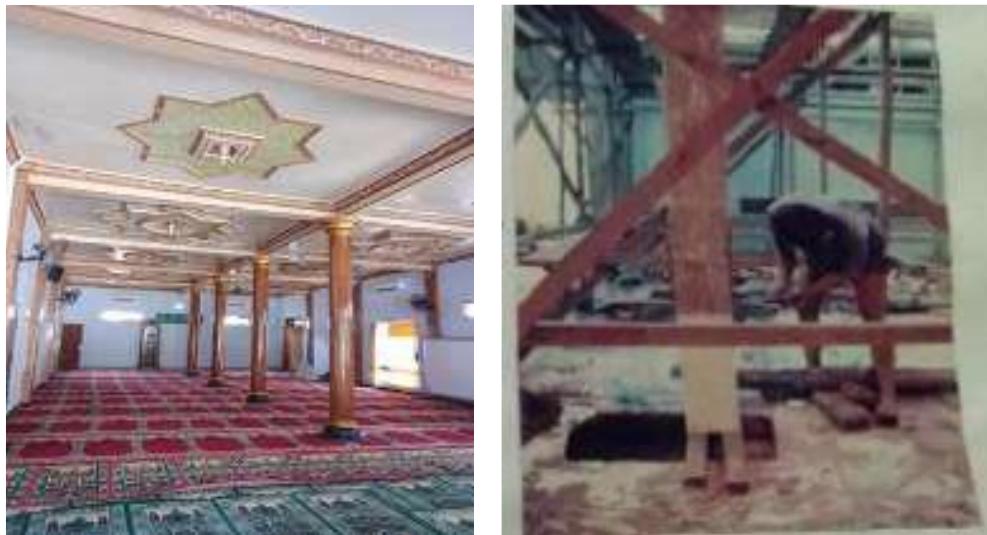
Figure 3. The Pawestren Space and the Process of Cutting the Serambi Columns

In the *serambi* area, dismantling was carried out comprehensively on the roof covering, structural frame, and columns, which were remnants of previous renovations. Non-original materials were separated for replacement, while original elements such as *usuk*, *blandar*, *jurai*, and truss columns were marked and registered so that they could be reinstalled in their original positions. The *serambi* floor was then dismantled to trace the presence of original *umpak* foundations concealed beneath layers of soil. Excavation revealed twelve andesite stone *umpak* with trapezoidal forms, which constituted an important component of the ancient mosque's structure. These *umpak* were conserved through thorough cleaning and the application of waterproof coatings to ensure the stability of the structural elements above them (Setyawan et al., 2017).

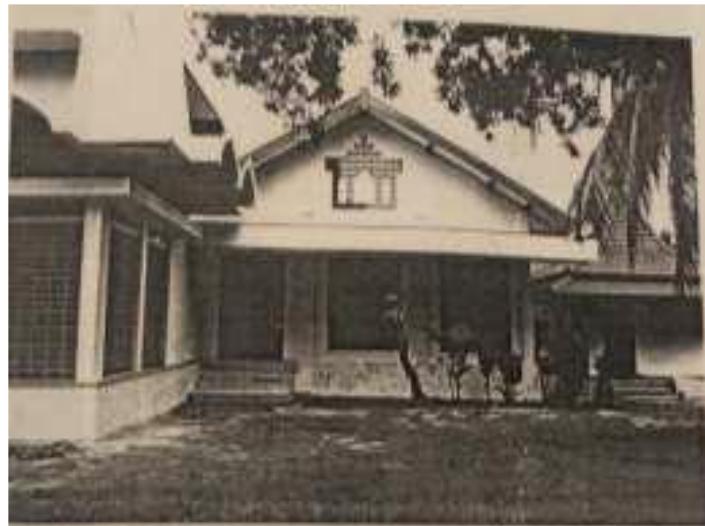
Figure 4. Photograph of the Restored Pawestren Viewed from the Front
